## Audio fix for blown TDA2822 (WX)

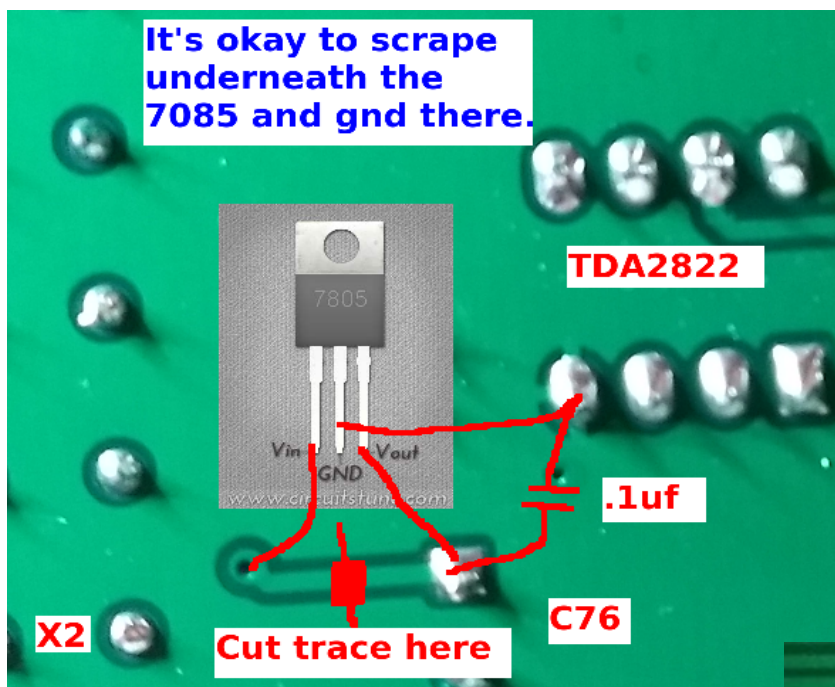
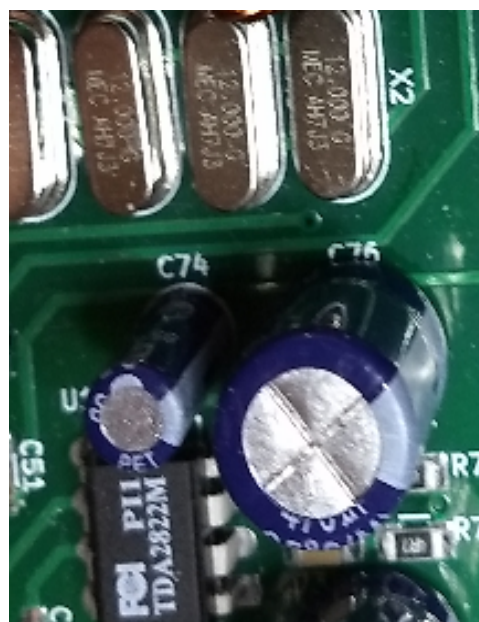
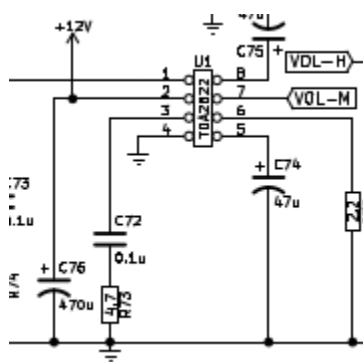
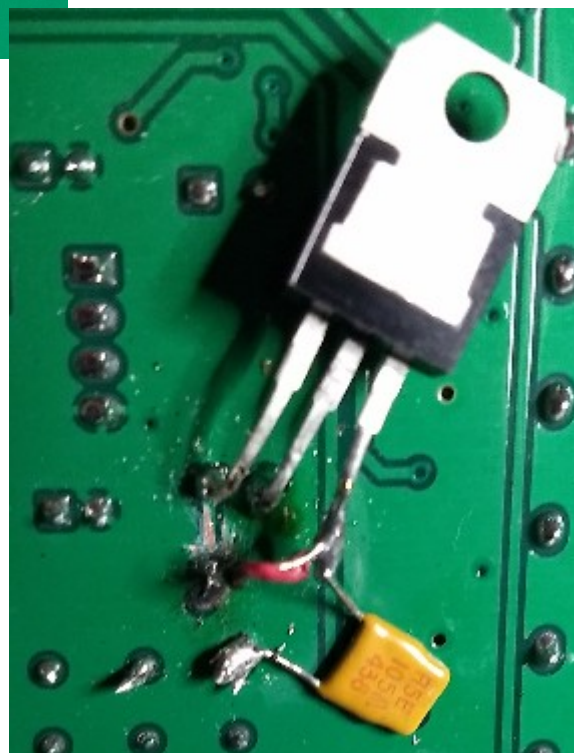
Reducing the supply voltage to 5v would pretty much eliminate these risks, and an extremely good idea if you wish to keep the WX part.

First step is to cut the short trace on the back of the board into the square pad of C76 (near X2).

Then add an LM7805 regulator, pin 3 goes to that square pad of C76, pin 1 goes to the feedthrough at the other end of the cut trace, pin 2 goes to ground.

Ideally, add a 0.33uF (or anything from 0.1 to 10uF) cap from pin 1 to ground.

Maybe glue the LM7805 face down onto the back of the board, the leads in the vicinity of C76.
